NSW EPBC GROUNDWATER MONITORING DATA QUARTERLY REPORT

Quarter 1: 1 January – 31 March 2026

This compliance report has been prepared to address condition **7(c)** of The Narrabri Gas Project Approval, Gunnedah Basin NSW (EPBC 2014/7376) dated 24 November 2020.

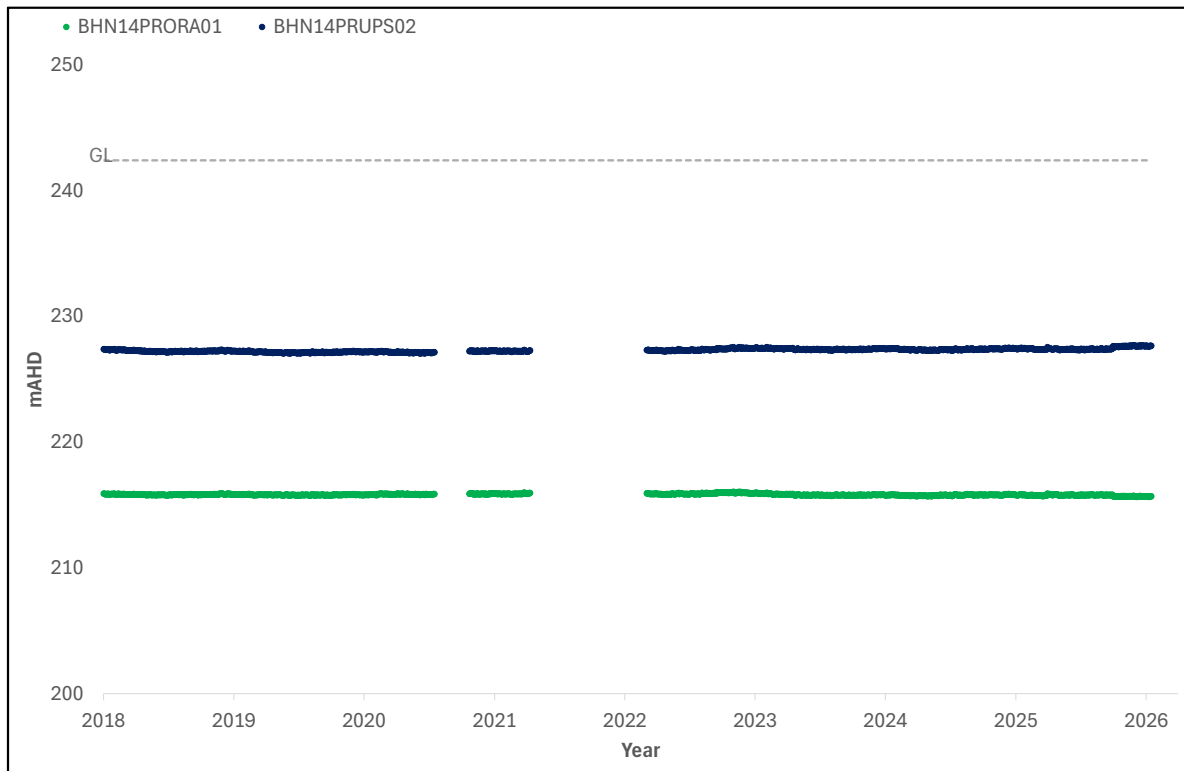
Figure 1: Bohena 14 Groundwater Level Hydrographs

Data from these monitoring points remained generally stable throughout the reporting period and is consistent with long-term trends. This location was identified to be faulty in January 2026 and is being investigated.

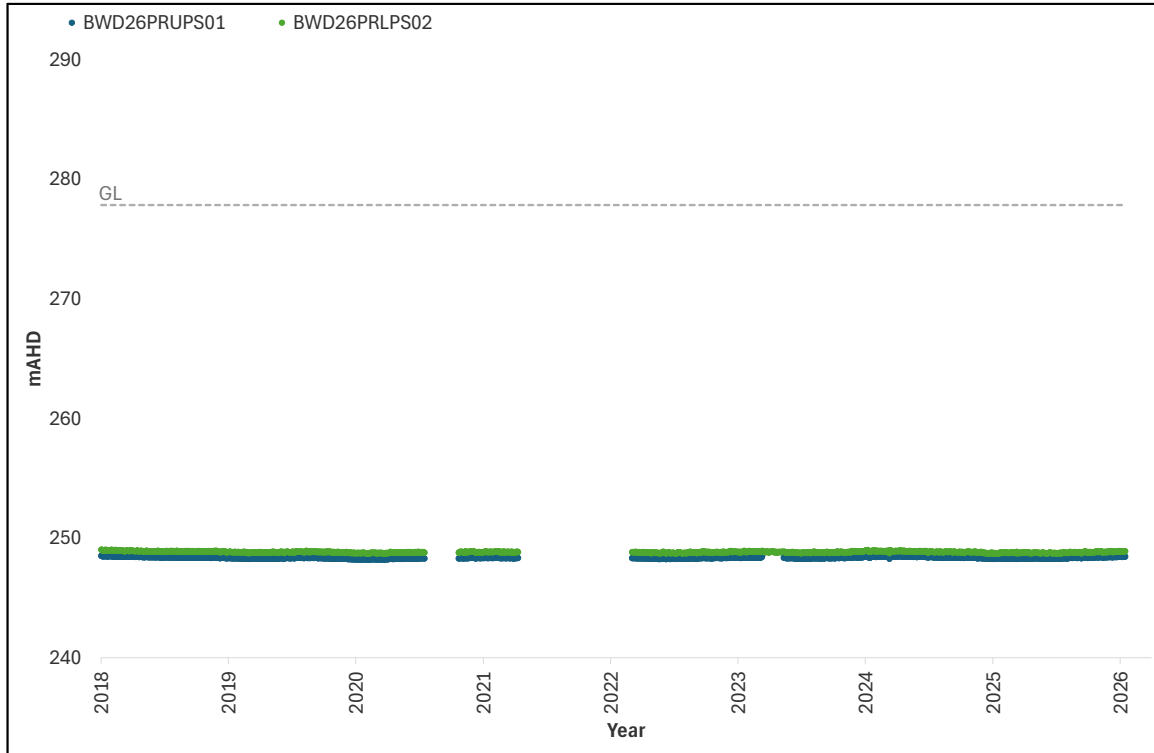
Figure 2: Biblewindi 26 Groundwater Level Hydrographs

Data from these monitoring points remained generally stable throughout the reporting period and is consistent with long-term trends. This location was identified to be faulty in January 2026 and is being investigated.

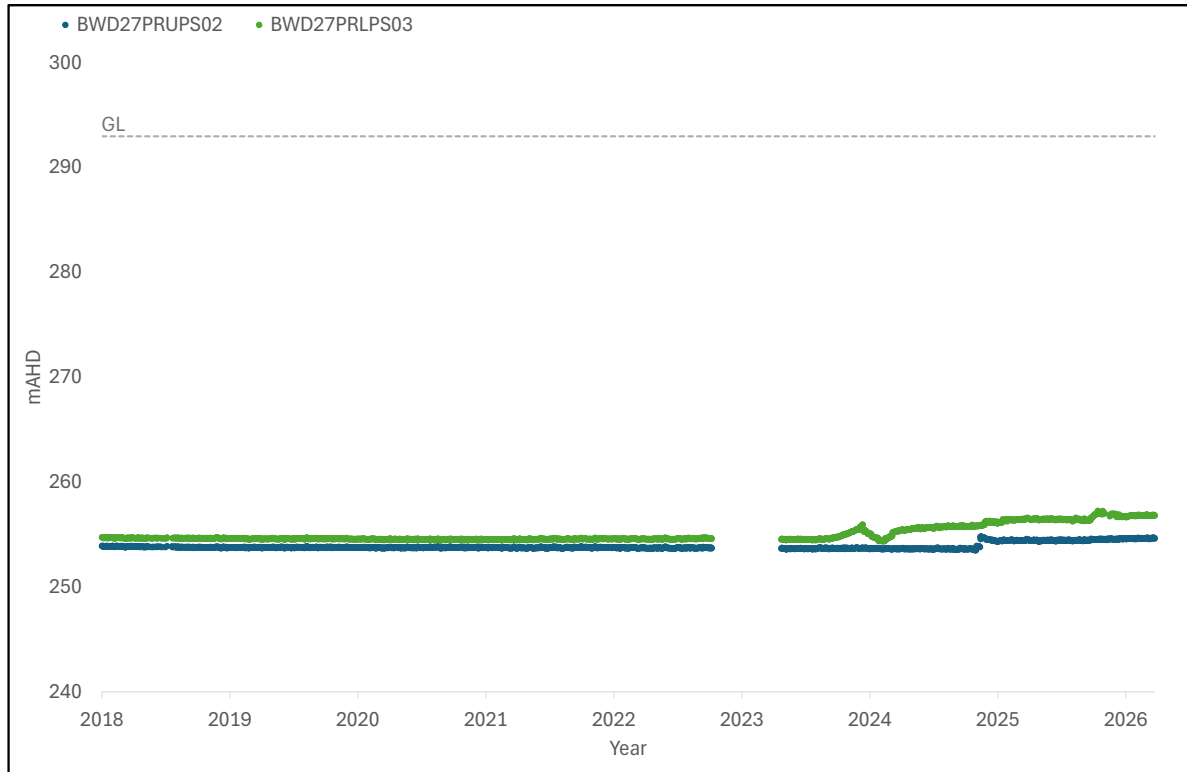
Figure 3: Biblewindi 27 Groundwater Level Hydrographs

Data from these monitoring points remained generally stable throughout the reporting period. Water levels have increased since 2024; however, the cause of this rise is unknown and is not considered to be related to CSG production.

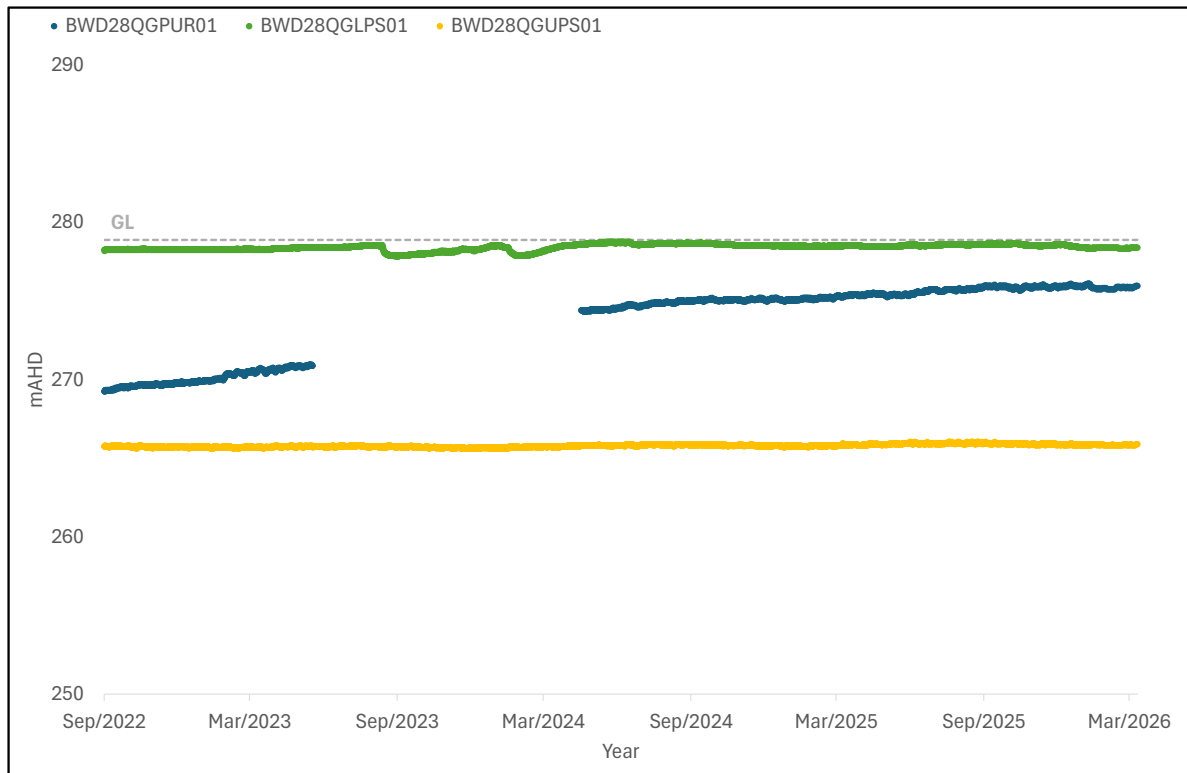
Figure 4: Biblewindi 28 Groundwater Level Hydrographs

Data from these monitoring points is generally stable across the reporting period (noting that there were telemetry issues from mid-2023 at BWD28QGPUR01 that were rectified in mid-2024) and is consistent with previous long-term trends.

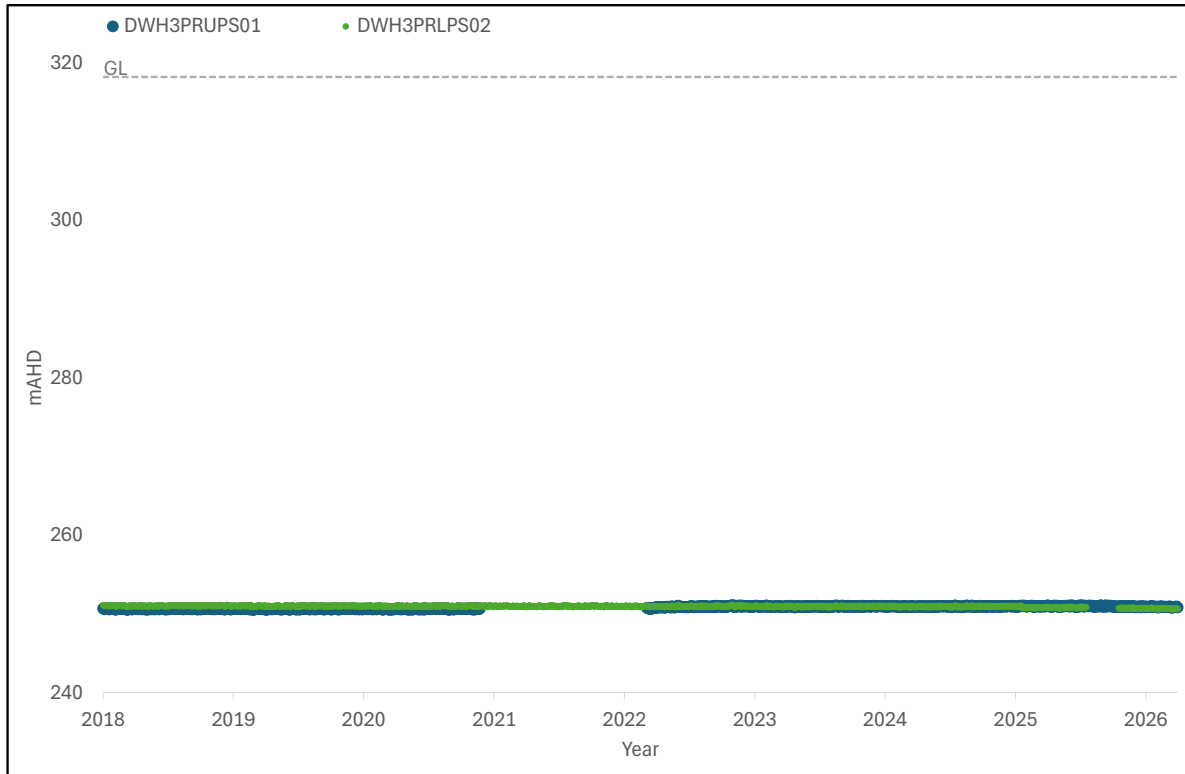
Figure 5: Dewhurst 3 Groundwater Level Hydrographs

Data from these monitoring points is generally stable across the reporting period. The sensor was identified to be faulty and was replaced in October 2025.

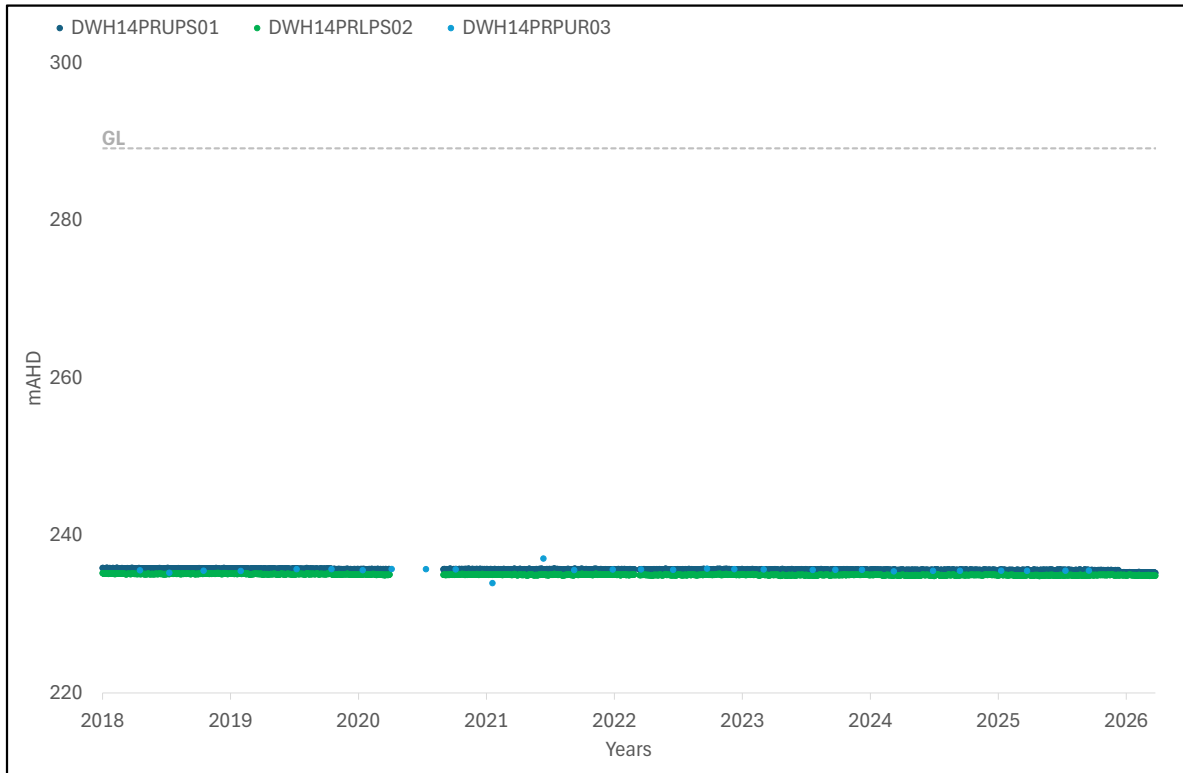
Figure 6: Dewhurst 14 Groundwater Level Hydrographs

Data from these monitoring points is stable across the reporting period and is consistent with previous long-term trends.

Dewhurst 14 location refers to three dedicated monitoring bores, DWH14PRUPS01 which targets the Upper Pilliga, DWH14PRLPS02 which targets the Lower Pilliga and DWH14PRPUR03 which targets the Purlawaugh Formation. DWH14PRPUR03 manual dip water level data has been included for this reporting period. Santos is planning to install a level logger at this site.

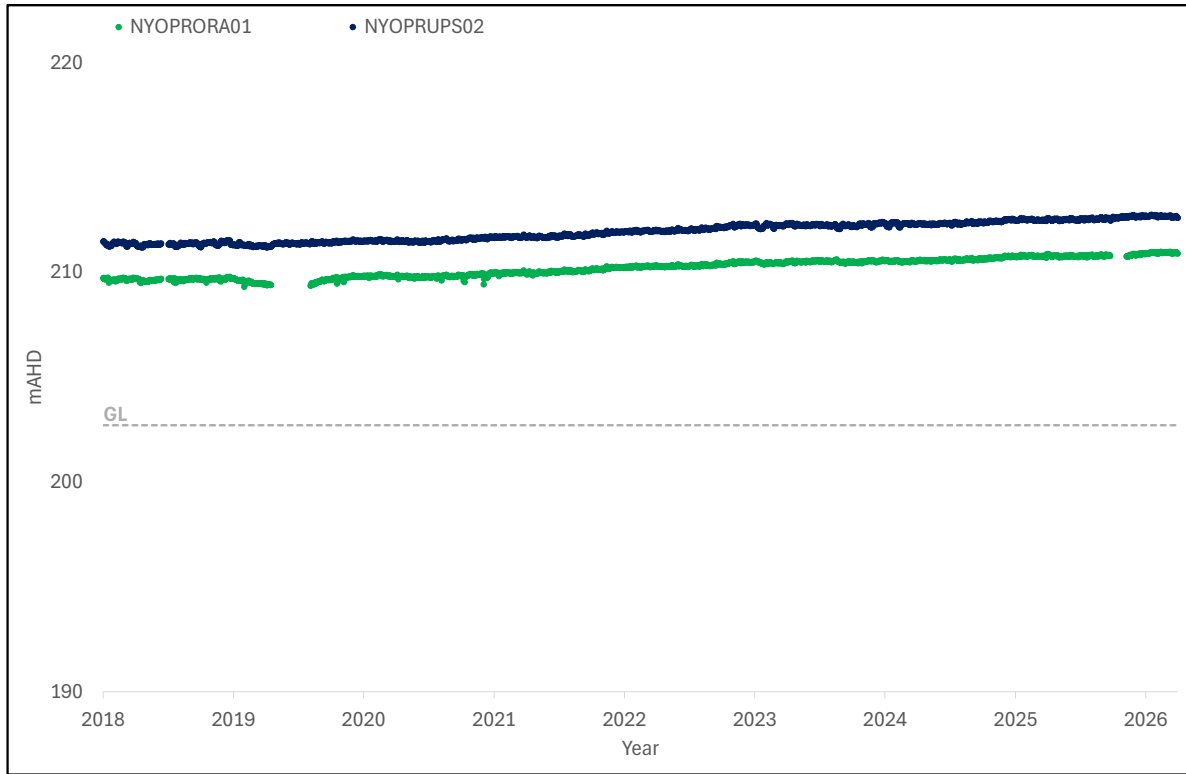
Figure 7: Nyora Groundwater Level Hydrographs

Data from these monitoring points is stable across the reporting period and is consistent with previous long-term trends.

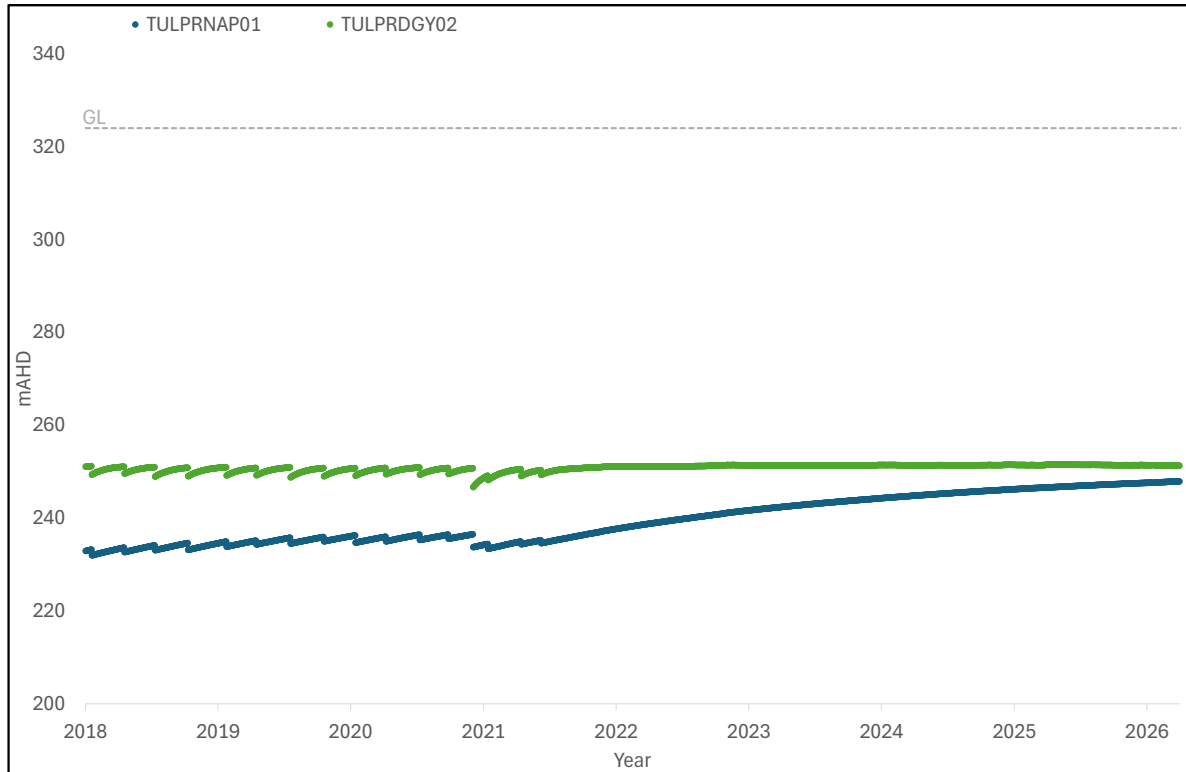
Figure 8: Tullamullen Groundwater Level Hydrographs

Water levels in TULPRNAP01 continued to rise throughout the period of record, suggesting the monitored formation is of very low permeability and has not yet equilibrated to a static water level.

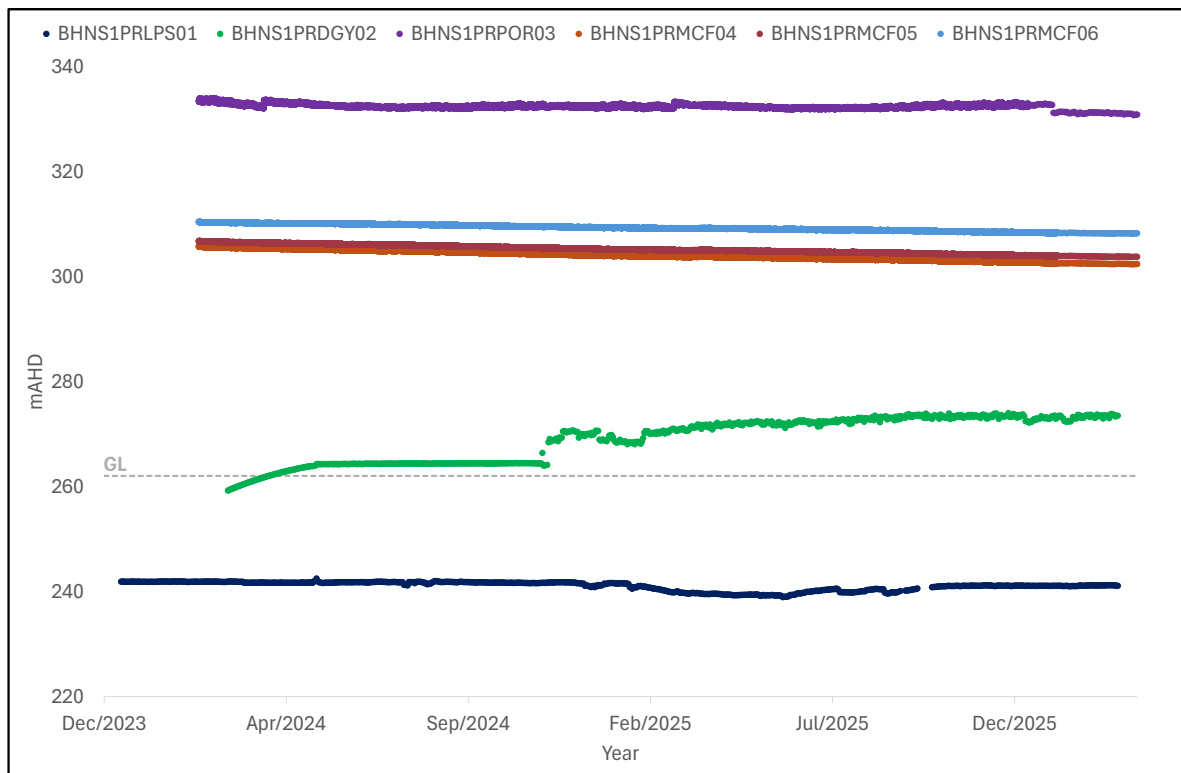
Figure 9: Bohena South 1 Groundwater Level Hydrographs

Data from these monitoring points is generally stable across the reporting period and is consistent with previous long-term trends.

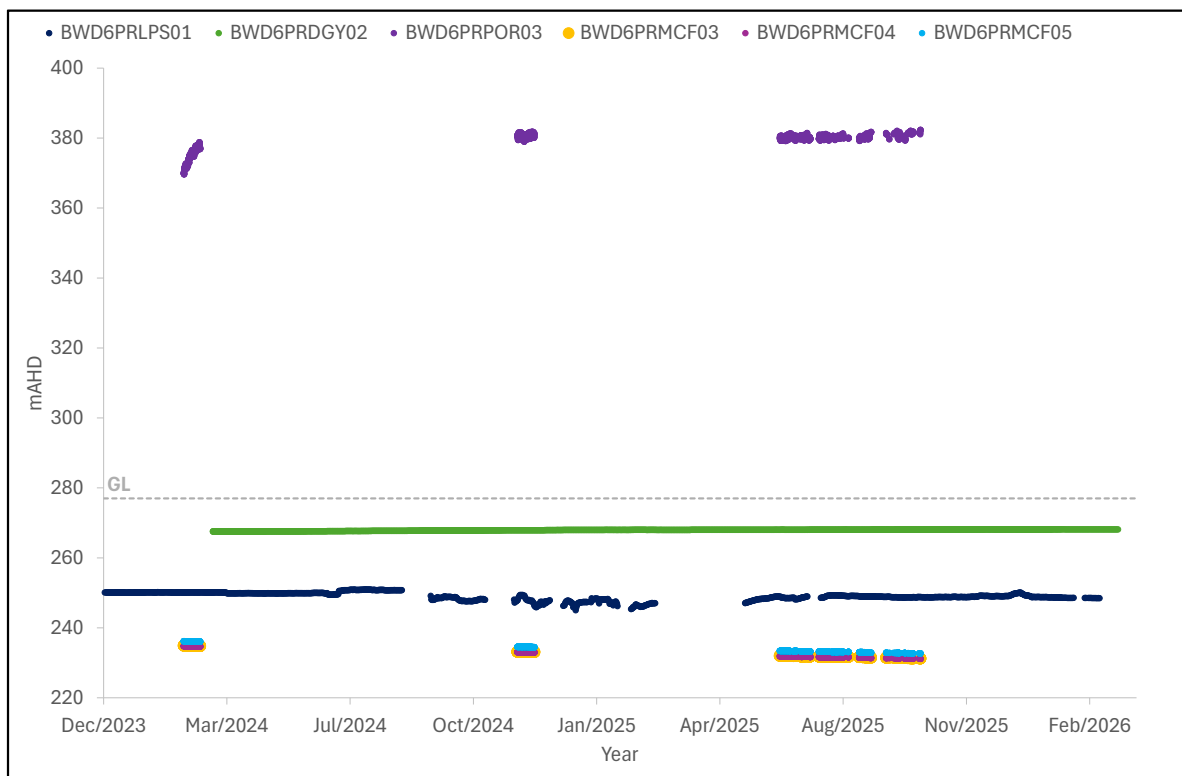
Figure 10: Biblewindi 6 Groundwater Level Hydrographs

Data from these monitoring points is generally stable across the reporting period and is consistent with previous long-term trends (except for sensor issues at BWD6PRLPS01 between Q3 2024 to Q2 2025). BWD6PRPOR03, BWD6PRMCF03, BWD6PRMCF04 and BWD6PRMCF05 monitoring points were identified to be faulty in Q4 2025 and are being investigated.

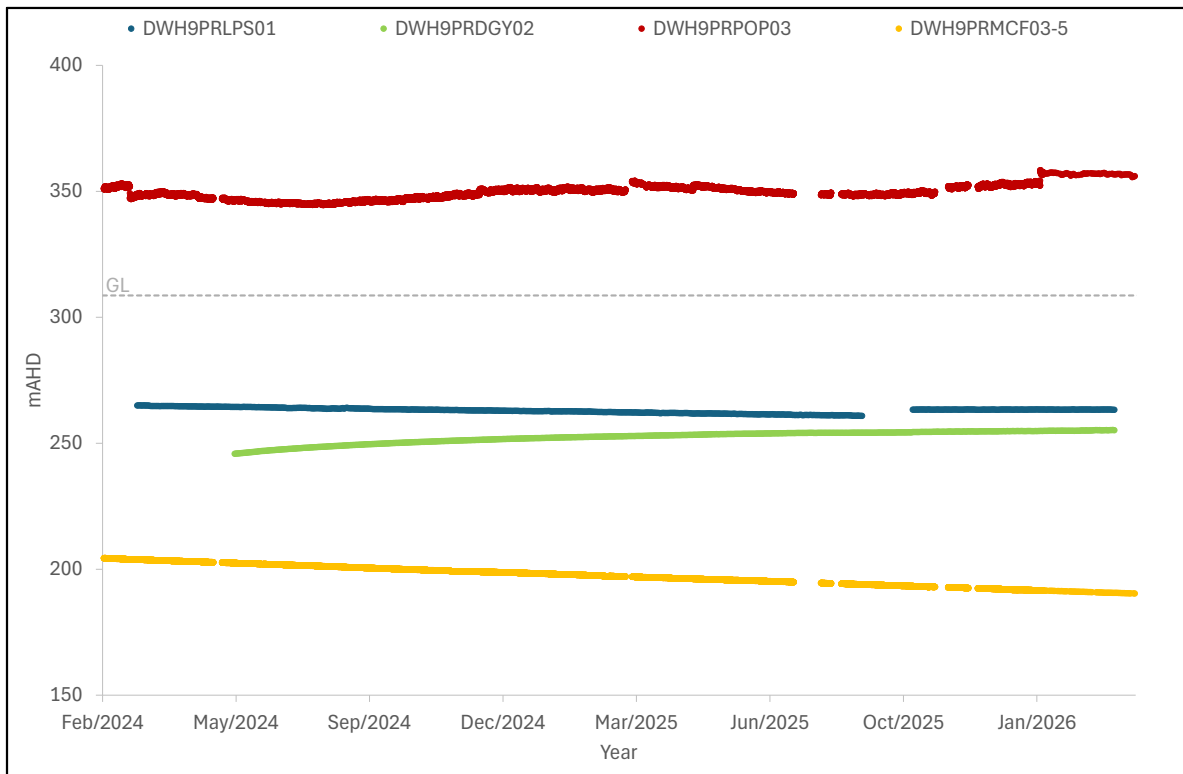
Figure 11: Dewhurst 9 Groundwater Level Hydrographs

Data from these monitoring points is generally stable across the reporting period and is consistent with previous long-term trends.

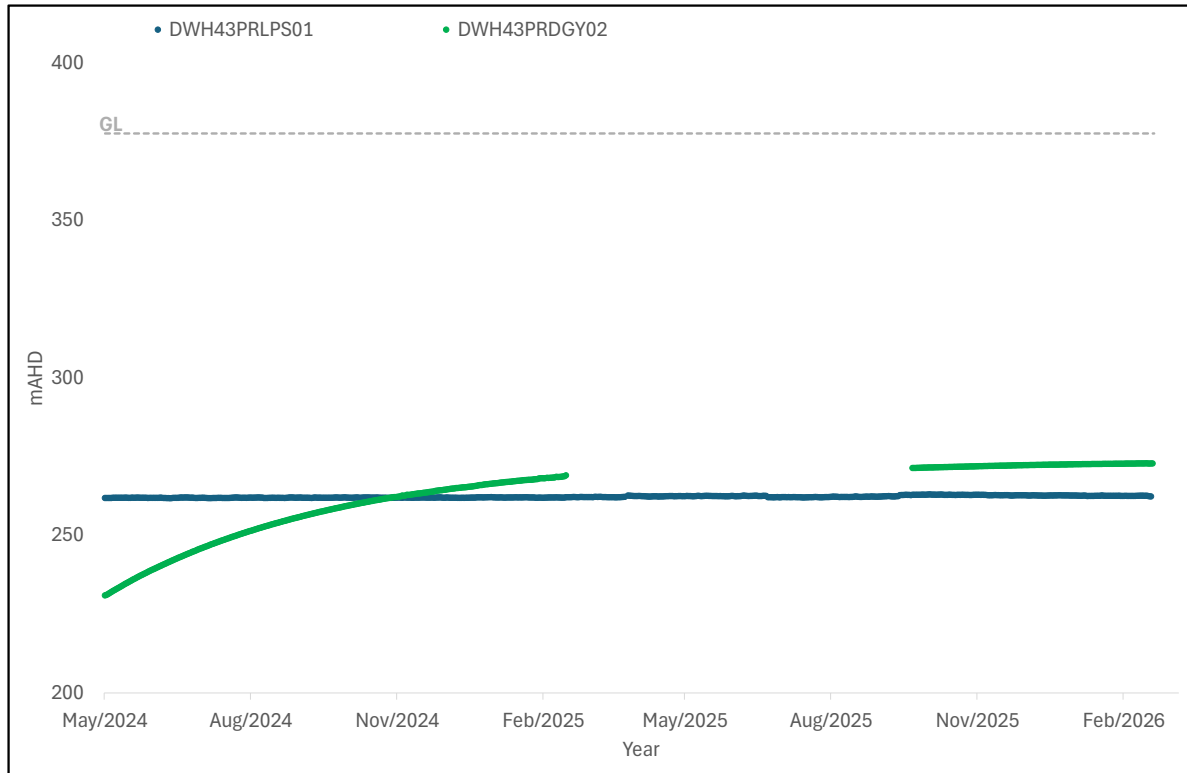
Figure 12: Dewhurst 43 Groundwater Level Hydrographs

Data from DWH43PRLPS01 is stable across the reporting period and is consistent with previous long-term trends.

DWH43PRDGY02 pressure data was identified as erroneous from March 2025. The sensor was identified to be faulty and was replaced in October 2025.

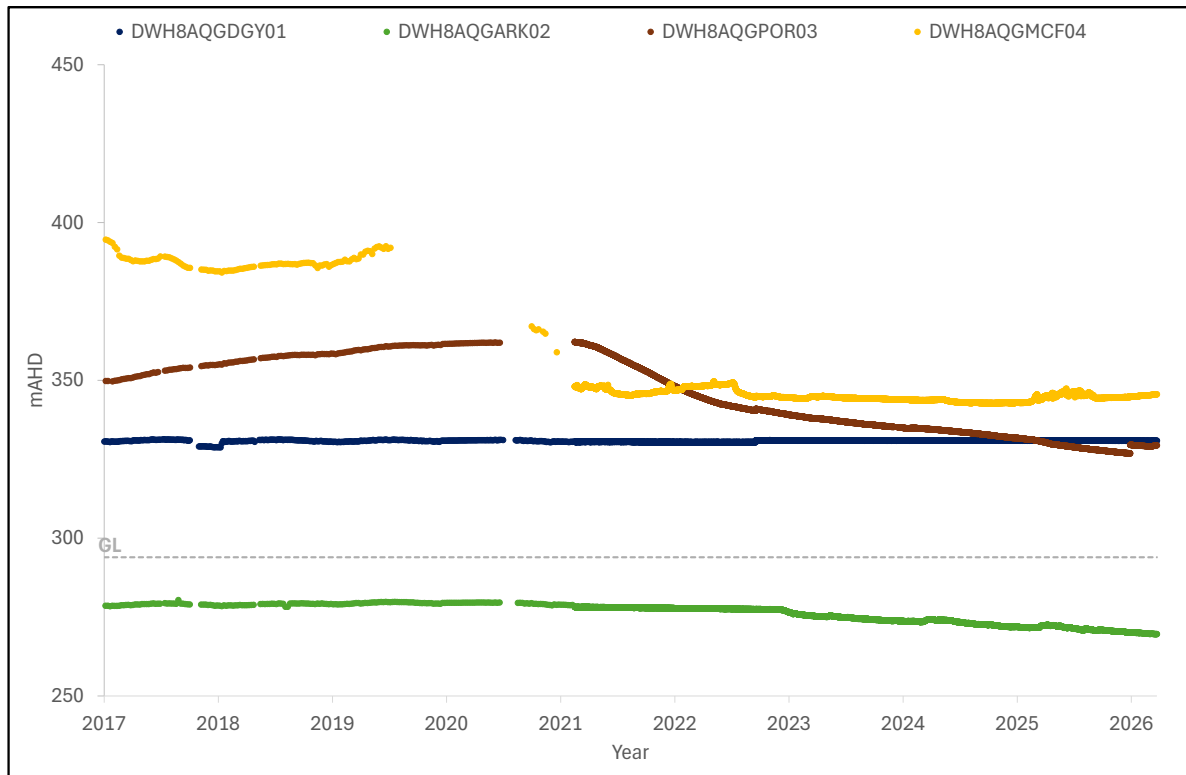
Figure 13: Dewhurst 8A Groundwater Level Hydrographs

Data from these monitoring points is generally stable across the reporting period and is consistent with previous long-term trends. Water levels in DWH8AQGPOR03 continued to decline through the reporting period. Similar declines were also observed in groundwater levels in the Maules Creek Formation suggesting a higher degree of connectivity between the two formations at this location. This is not a level trigger monitoring point. The data is being collected to enable groundwater model validation for Phase 2 of the project.

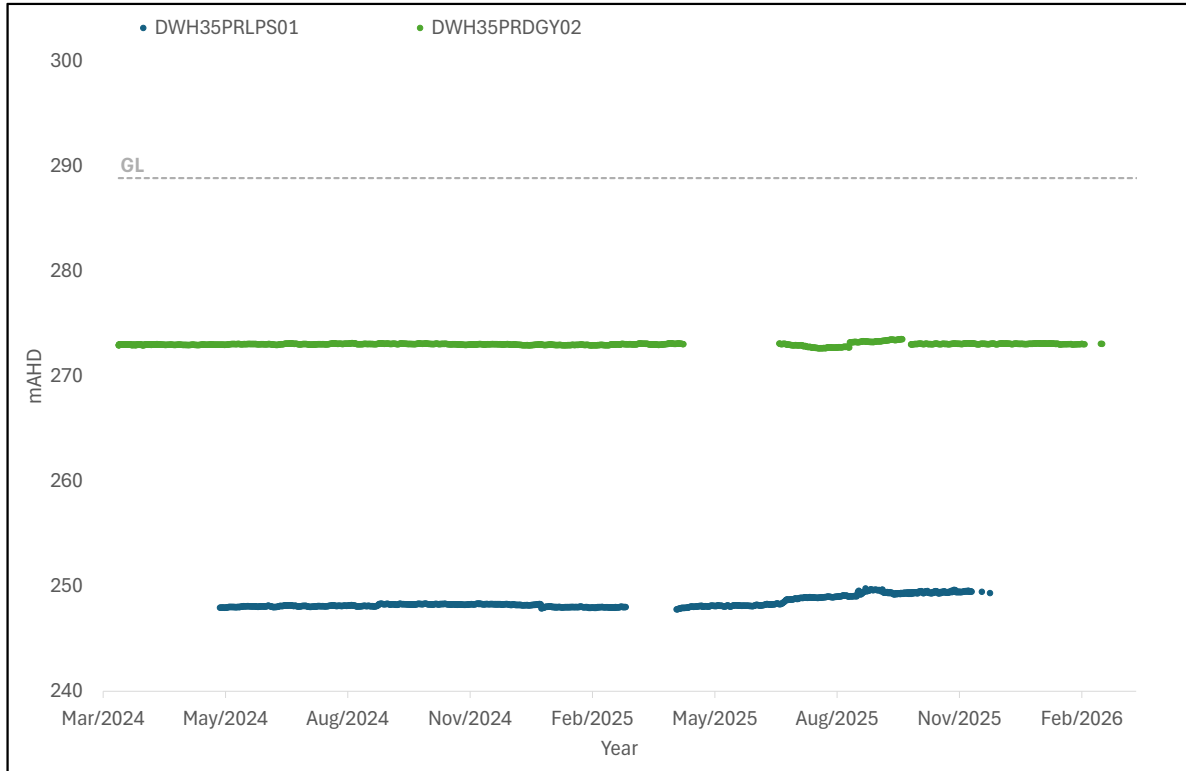
Figure 14: Dewhurst 35 Groundwater Level Hydrographs

Data from these monitoring points is generally stable across the reporting period and is consistent with previous long-term trends. DWH35PRLPS01 monitoring point was identified to be faulty in Q4 2025 and is being investigated.
